## **Preparation of molds for rubber molding to ensure smooth start-up in production**

*By George Barton, Chem-Trend Limited Partnership, April 14, 2006*

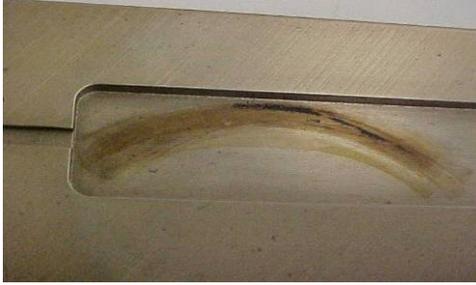
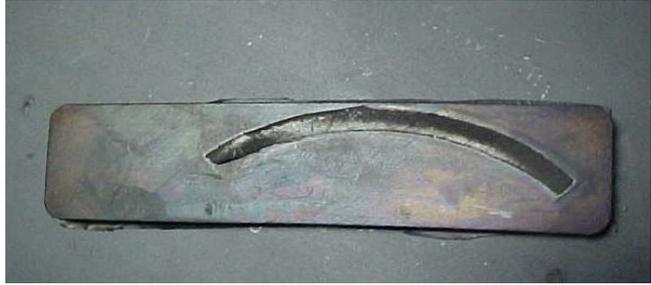
To illustrate the situation in rubber-to-metal bonding, here is a photo, (below left), of a mold that has been in contact with an adhesive-treated curved metal, followed by hot bonding to the compound. In this case, it is a typical natural rubber formulation used in the production of motor mounts for vibration isolation or noise, vibration, harshness (NVH) reduction in a motor vehicle suspension system. The actual molded part is on the right.

This amount of fouling was produced within 30 heats of the mold being cleaned. In order to cause this accelerated fouling, for test illustration purposes, a mold release having very poor barrier properties was selected and the adhesive-treated metal was loaded into the mold about ten minutes prior to commencement of the molding cycle. Although there is likely to be a contribution to the mold fouling from the rubber compound, the bulk of this mold contamination probably originated in the adhesive. In a regular production environment, one would attempt to encapsulate the coated metal in the rubber compound as soon after loading into the mold as possible, to minimize the effects of bonding agent sublimation and re-deposition on the mold surface.

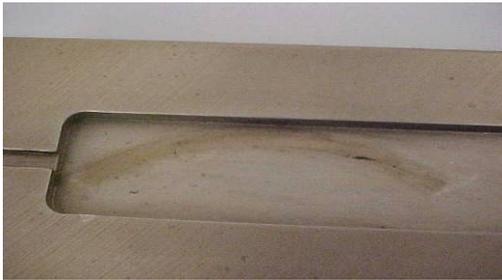
This kind of mold fouling can be greatly reduced by employing a good quality semi-permanent release system. Compare the photo below with the previous one.

The degree of fouling is much less extreme, mainly because the release system employed has enough barrier property to prevent large-scale re-deposition of the bonding agent on the mold surface.

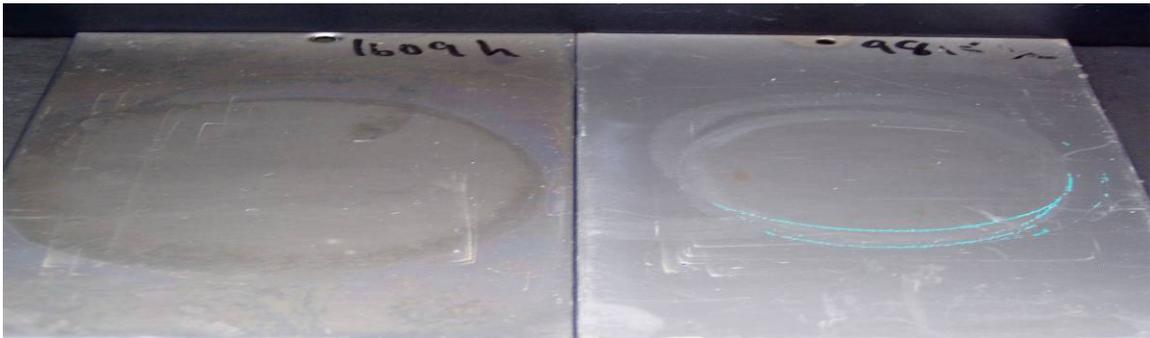
As an illustration of the type of fouling seen in the production of gaskets and shaft seals, here is a photo, of two test panels that have been used in the molding of a very high quality peroxide-cured FKM compound, designed to work in a hot, gasoline vapor environment. This is a sulfur-free compound. The mold fouling takes on a very different appearance here.

The photo on the right shows a light blue ring that is actually uncured compound, brought about through the presence of oxygen at the air/compound interface as the compound, under molding pressure, moves across the test panel surface during the molding operation. Oxygen restricts the cure process at this interface and de-molding leaves behind an uncured ring every molding cycle, leading to rapid in mold build-up and subsequent reject parts. Although this uncured ring is very sticky, the molded disc within its perimeter could be removed quite easily from the test panel. This serves to illustrate that the adhesive forces of the uncured ring on the treated panel surface are greater than the cohesive forces within the uncured rubber compound itself. The photo on the left is of a panel coated in a superior mold release that prevents the uncured ring sticking to it, illustrating that the release ease is lower than the cohesive forces within the rubber compound, a truly great situation to prevent uncured rubber build-up on the mold surface.

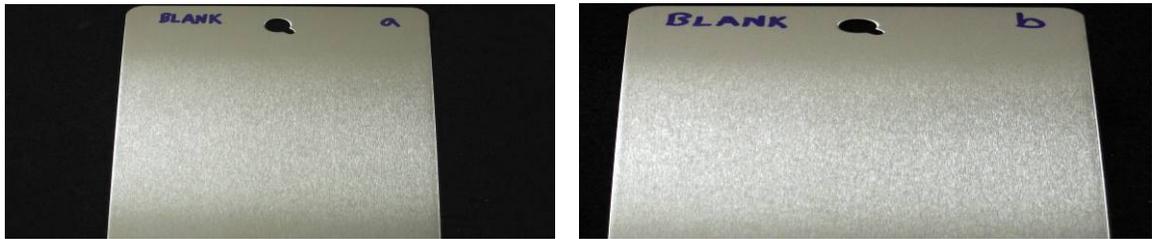
Here are two photos, one taken of a blank panel and one of a blank panel treated with mold release agent, prior to the molding of a test compound.

There is no discernable difference in appearance

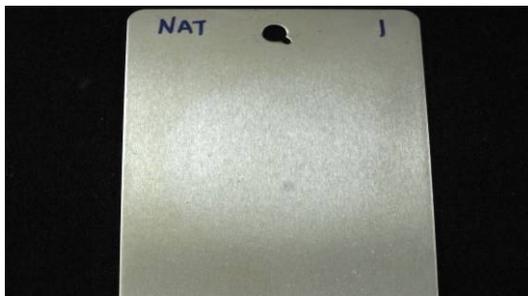
Immediately after coating

Here are photos of the panels used for natural rubber molding, coated with the anti-moisture barrier

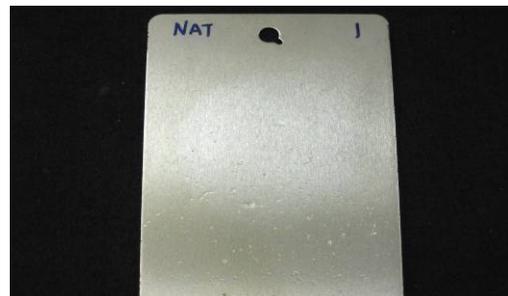
After 5 days exposure at high humidity

Although one can quite clearly see the disc where the molded rubber has been in contact with the panel, there is no visible difference in the surface appearance of the two panels. The anti-moisture barrier has, indeed, been very effective in preventing the two things that cause corrosion, oxygen and moisture, from attacking the metal surface.

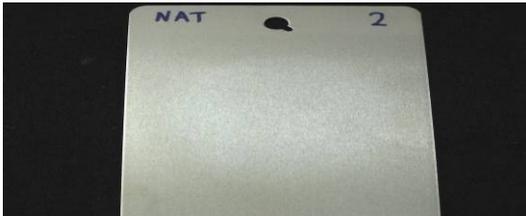
Immediately after coating

Here is a photo of the panels used in natural rubber molding, coated with a state-of-the-art semi-permanent mold release product

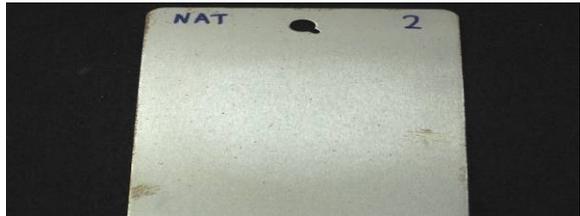
After 5 days exposure at high humidity

It is quite clear that the panel surface has changed. Exposure to humidity has penetrated the micro-thin film of the semi-permanent mold release system and brought about some corrosion of the panel, albeit quite minimal. It is reasonable to conclude that the metal surface has not been fully isolated from the factors that cause oxidation i.e. air and moisture.

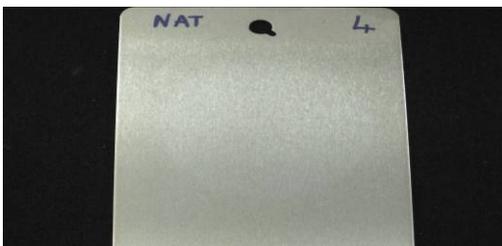
Immediately after blasting

Now, look at a pair of panels that molded the same natural stock and were not given any surface treatment

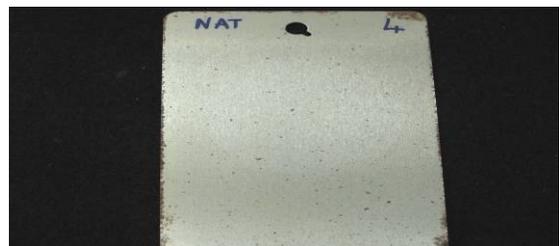
After 5 days exposure at high humidity

The exposed panel has suffered noticeable corrosion over its whole surface. It is reasonable to assume that the effect of having molded some natural rubber on this panel (the circle where the molding took place is still evident) has not resulted in any additional corrosion in the contact area.

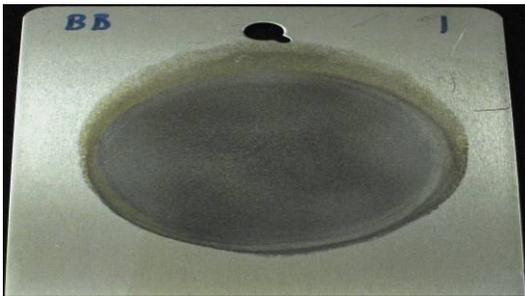
Immediately after coating

Here are the photos of panels used in molding the bromobutyl compound, coated with the anti-moisture barrier.

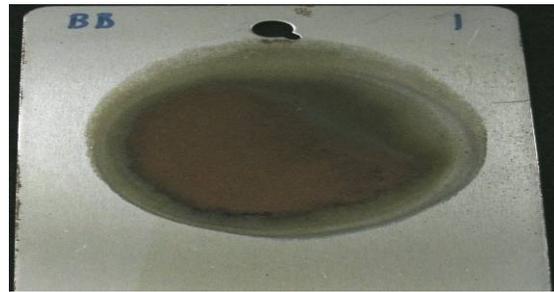
After 5 days exposure at high humidity

After exposure, there is only minor corrosion in the land areas of the panel, but most noticeably, the area where the disc has been molded has turned a rusty red color. This is a clear indication that even an anti-moisture barrier cannot totally isolate the metal from atmospheric oxygen and moisture

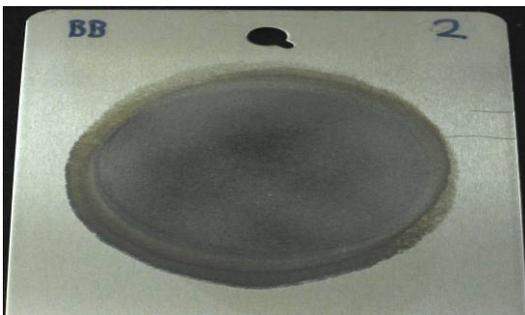
Immediately after coating

Now, look at the panels that have been coated in the solvent-based semi-permanent release agent

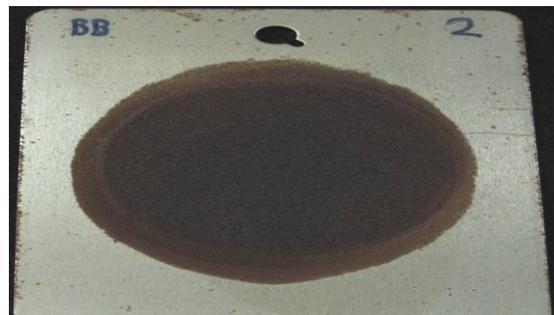
After 5 days exposure at high humidity

After exposure, corrosion of the panel areas is evident. Whilst not heavy, it is quite advanced. The area where the rubber disc has been molded is a very rusty red, indicating that the metal has not been fully protected from oxygen and moisture.

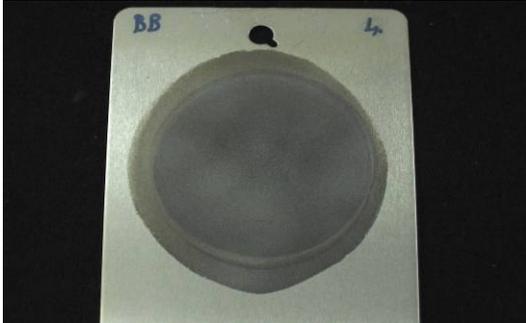
Immediately after blasting

To complete the sequence, here are photos of the two panels given no surface protection after molding with bromobutyl compound.

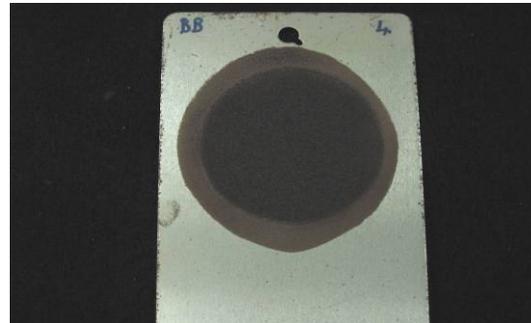
After 5 days exposure at high humidity

After exposure, the land areas of the panel were quite heavily corroded. The disc that had been in contact with molded rubber was red rusty, once again indicting the profound effect of the halogenated compound at the mold surface.
